Review from the Division for Investigation of Maritime Accidents

## **ATLANTIC / ARNGAST – Collision in the DW route east of Langeland, Denmark, 4 August 2005**

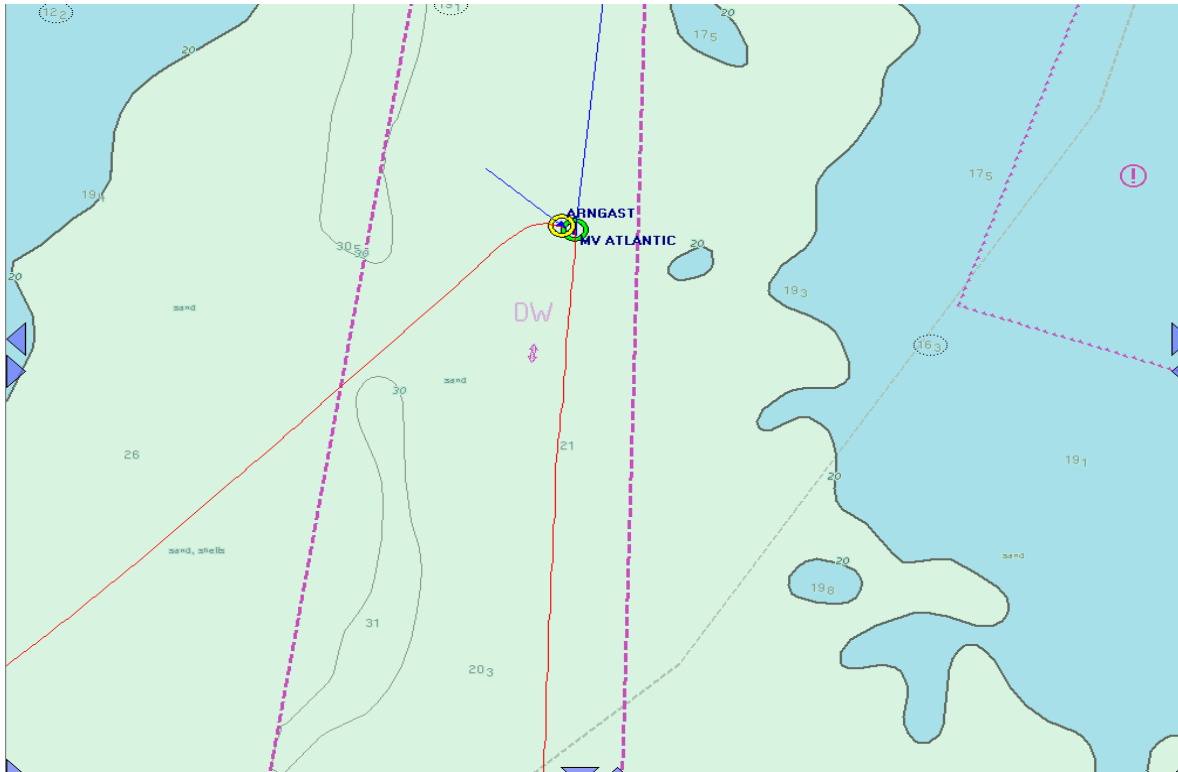
*Extract of the AIS plot from the Royal Danish Administration of Navigation and Hydrography's display system.*

According to the AIS plot the collision took place at 1050 hours in position 54°43,2' N - 010°46,7' E.

Also according to the AIS plot the distance between the ships was 2 miles when ATLANTIC at 1038 changed course to starboard to follow the DW route.

At 1047, when ARNGAST called ATLANTIC on VHF, the distance between the ships was 0.6 mile and both ships were on unaltered course and speed.
