# Marine Accident Report

BERGITTA /  
MSC EYRA  
Collision  
24 October 2004

## **Casualty report issued July 11, 2005**

**Case: 200503238**

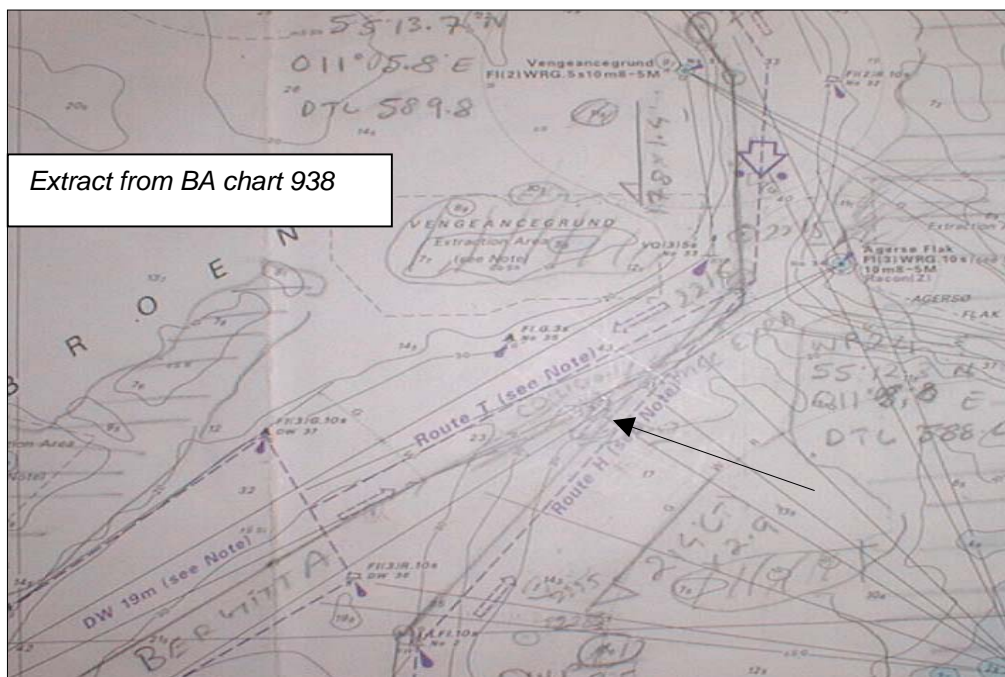
At 2220 hours the vessels collided in position: 55°11,44´ N 011°04,6´ E.  
See marking on the chart extract below

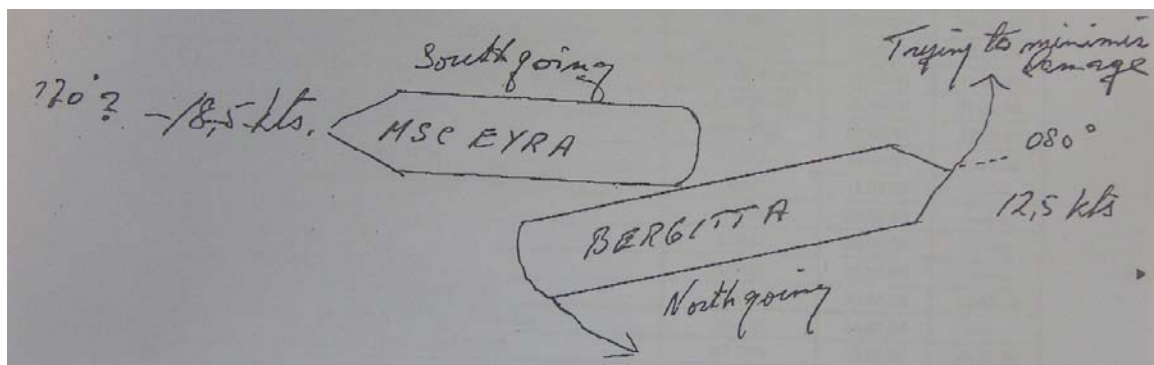
Sketch made by the master of BERGITTA

According to the master the angle between the vessels was approx. 180° (at almost opposite courses) at the time of the collision.

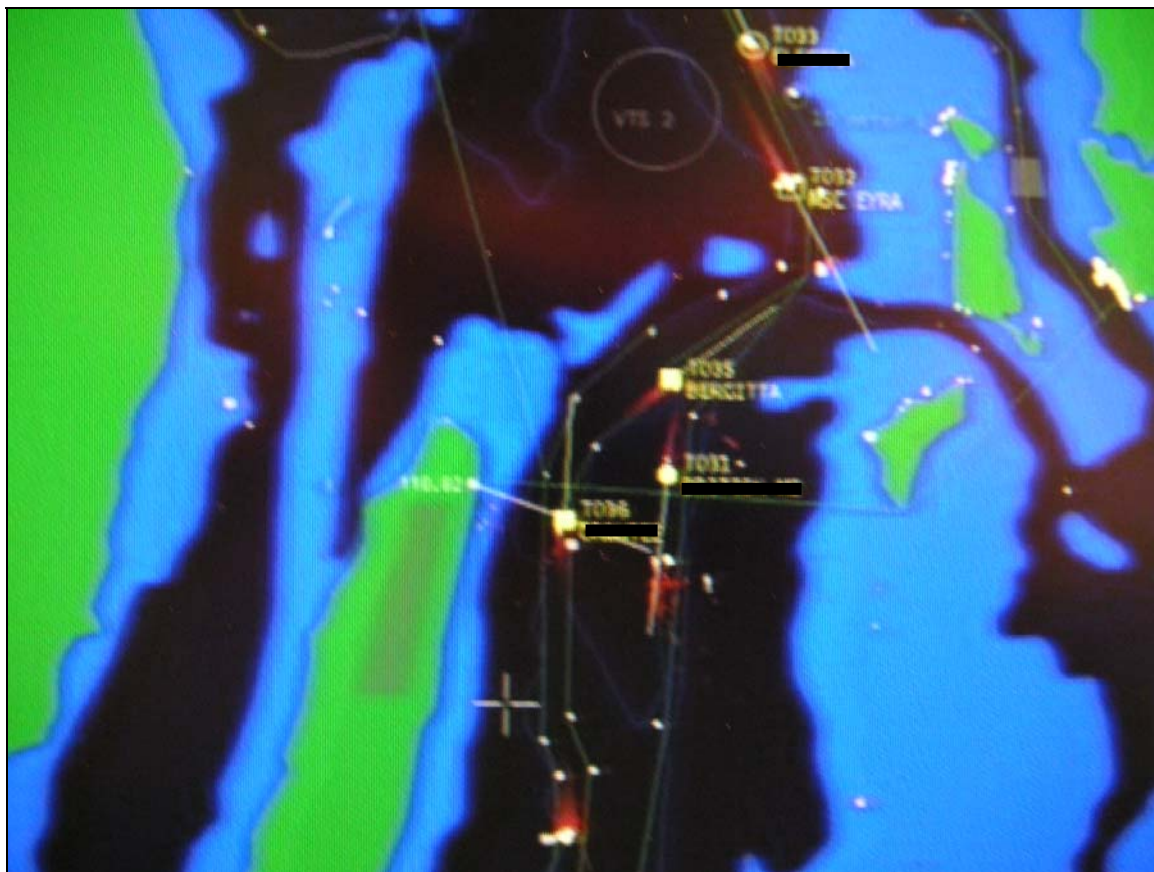
*Recording of radar at 22:10:30 hours local time. Vector: 10 minutes.  
The traffic situation and location of the vessels approx. 7½ minutes before the collision.  
For further details of the area see chart extract in chapter 3.  
The data obtained from the recordings as prescribed below is not to be regarded as exact – e.g. course alterations are shown on the radar with some delay.*

MSC EYRA is close to Vengeancegrund L/H on course 154°, speed 18 – 18.5 knots. The recordings shows that MSC EYRA (the vector) is on a southerly course about 1 ½ minutes later at 2212 hours.

True bearing between the vessels is 031° / 211°.

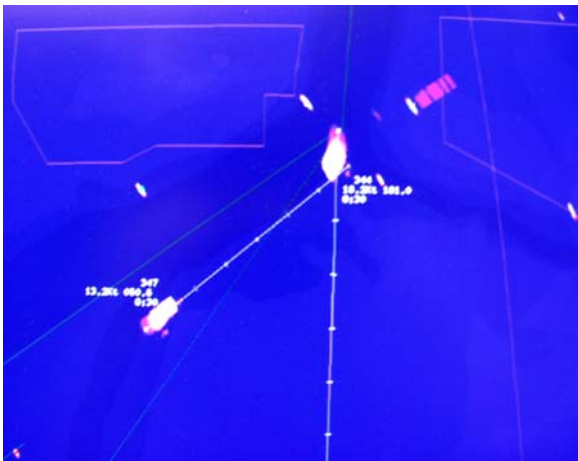
*Pictures taken of the radar recordings displayed on the VTS equipment.  
Vector: 6 minutes (distance between two dots represent 1 minute). Time: 22:15:41 hours.  
At 1500 hours approx. 3 minutes before the collision the distance between the vessels was about 1.5 NM.*

The shown vectors are not in the centre of the targets and can therefore not be regarded as precise. The trail and vector position of MSC EYRA, however, indicates that MSC EYRA has initiated a starboard turn.

MSC EYRA is or was about to pass the course line of the BERGITTA in a distance of approx. 1.5 miles.

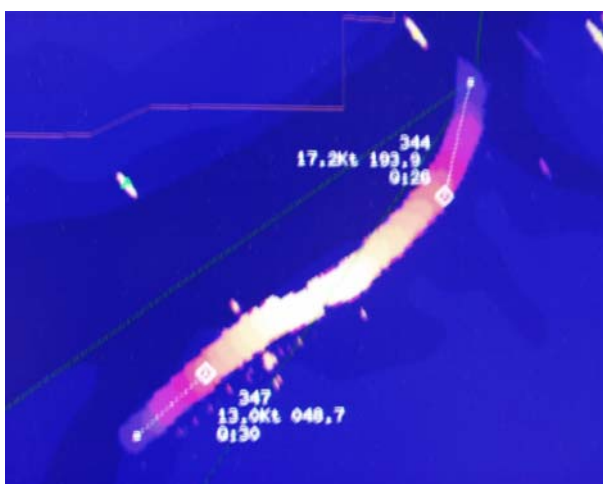
*Same starting point as shown above.  
In this picture with 3-minute tails.  
The echoes melt together at approx. 22.18 hours*

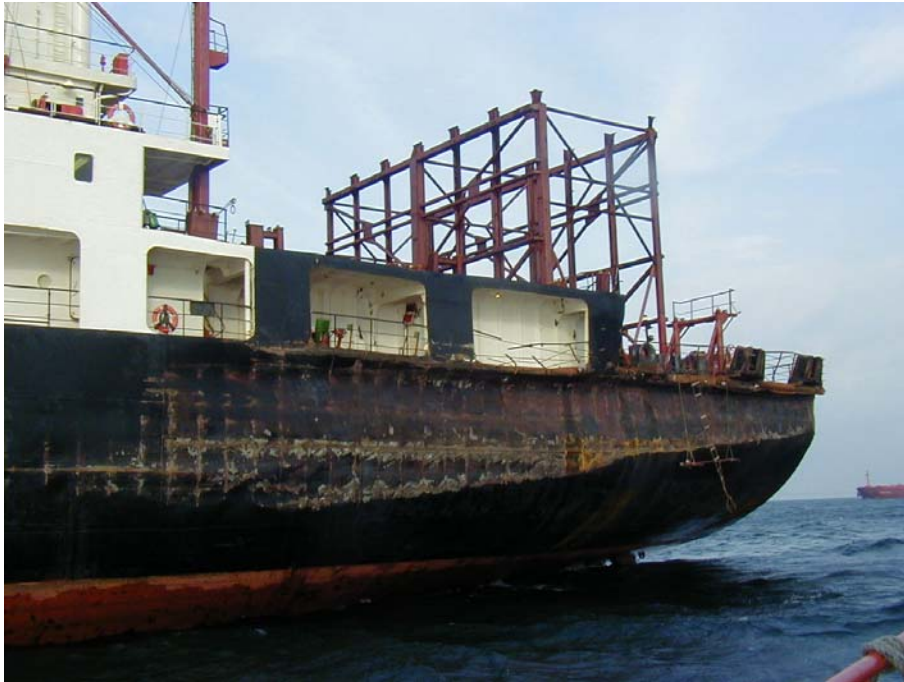
*MSC EYRA – port side quarter*

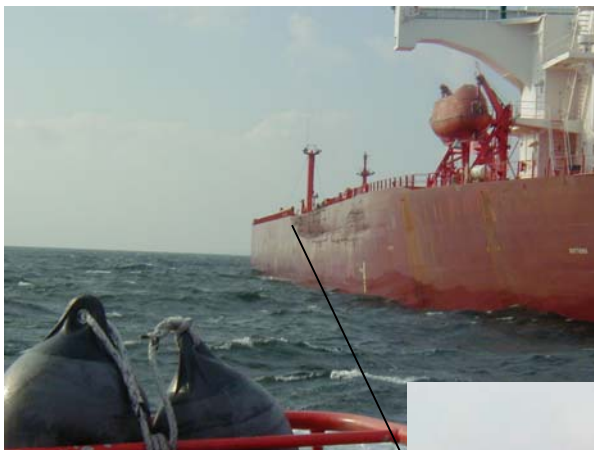
*BERGITTA - port side*
