Review from the Division for Investigation of Maritime Accidents

## **ATLANTIC / ARNGAST – Collision in the DW route east of Langeland, Denmark, 4 August 2005**

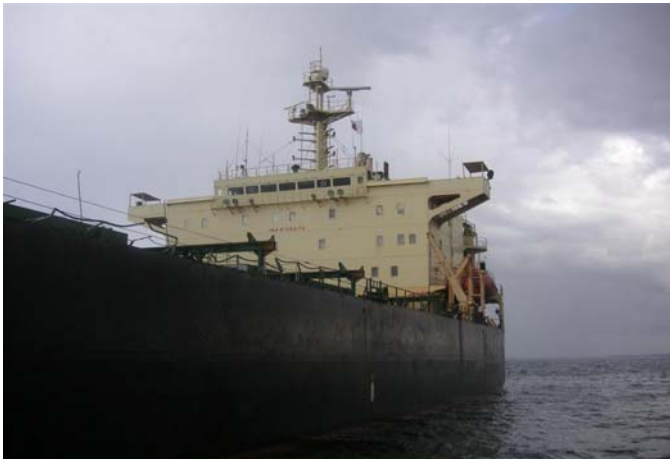
*ATLANTIC - Picture by the Investigation Division*

ATLANTIC suffered only minor above water damages, crumbling of the rail in port side. ARNGAST suffered above water damages in the bow. There was no pollution observed and no personal injuries.

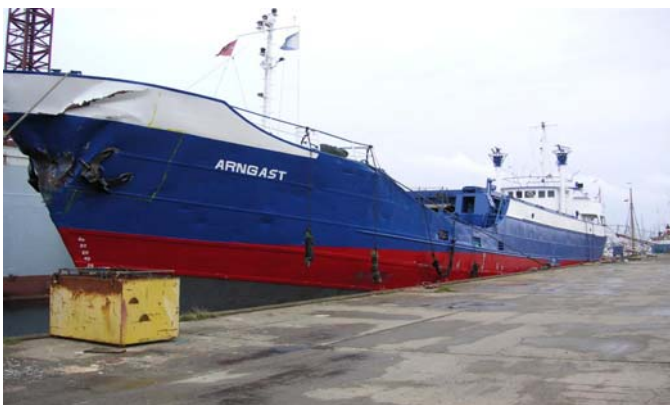
*ARNGAST – Picture by the Investigation Division*

allowed to sail to Marstal for repairs. The repairs were finalized and ARNGAST was released on 24 August.
