# Marine Accident Report

BERGITTA /  
MSC EYRA  
Collision  
24 October 2004

## **Casualty report issued July 11, 2005**

**Case: 200503238**

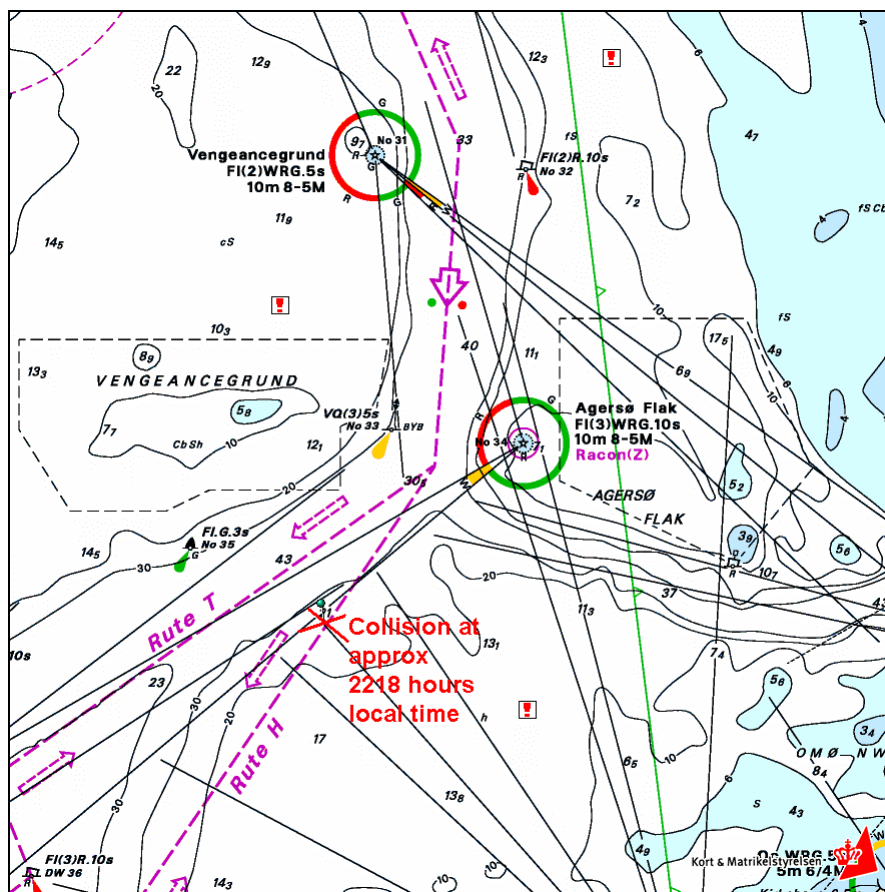
Extract from chart INT 1369 (chart 143)

Area of accident	Southwest of Agersøe Flak
Injured persons	None
Evacuation of injured persons	None
Ship abandoned (usage of either rescue boat or fleet)	No
IMO Casualty Class	Serious

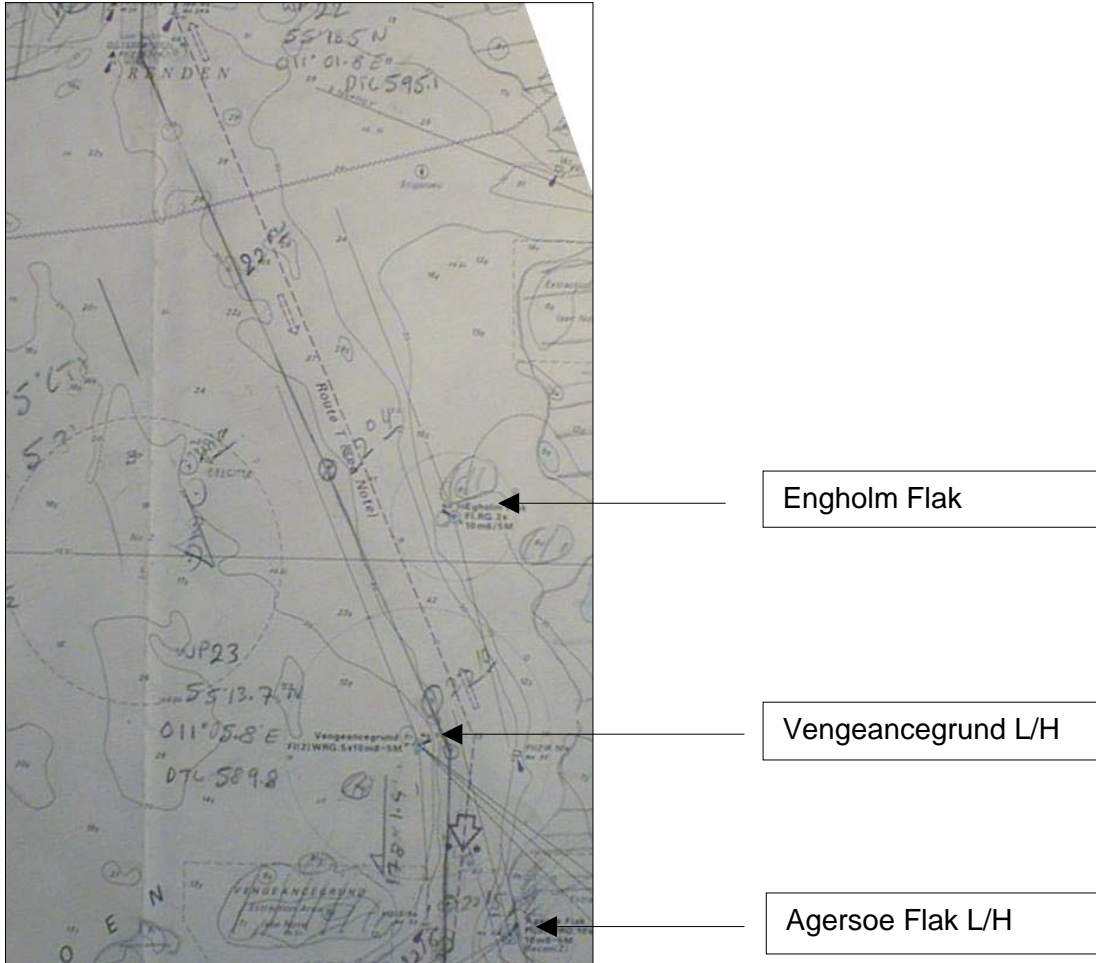
Extract from BA chart 938

Positions from the GPS were marked in BA chart 938 (INT 1369) with intervals of approx. 5 minutes – see *chart extract below*.

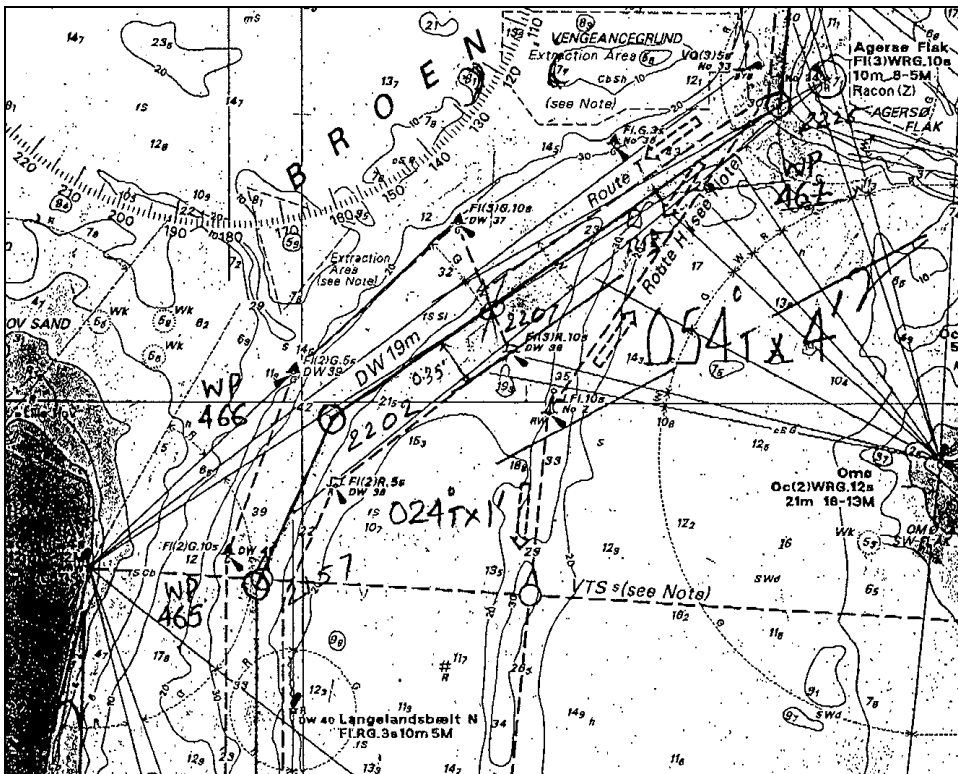
Extract of BA chart 2597

The 3<sup>rd</sup> officer checked and inserted the positions in the chart at all waypoints and in addition regularly between the waypoints – *see chart extract below*.

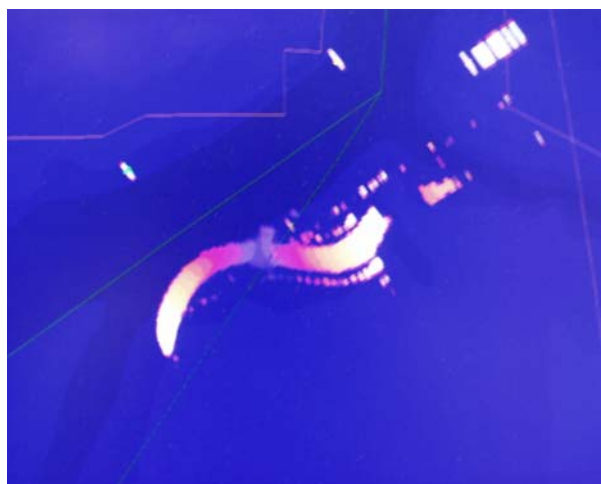
*Manoeuvres after the collision.*

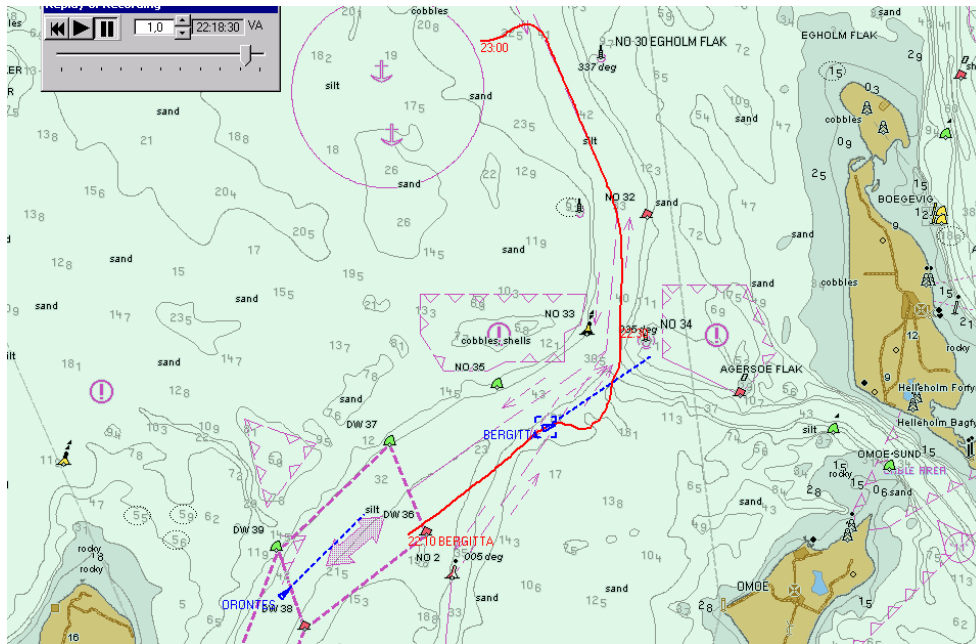
*BERGITTA's track in accordance with the AIS test facilities of the Danish Administration of Navigation and Hydrography.*

There is no AIS information from MSC EYRA. Nothing was detected.

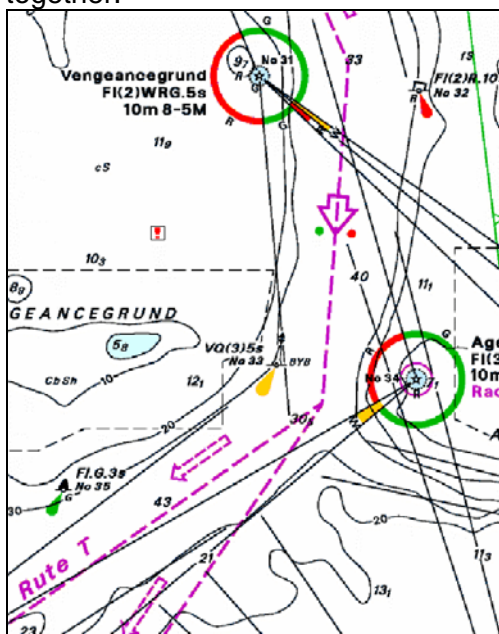
### ***The Agersoe Flak sea area***

The passage at Agersoe Flak is narrow. The distance between buoy 33 and the 20 meter-curve at Agersoe Flak is approximately 0.4 nautical miles.

Route-H meets route-T at Agersoe Flak. Ships, like MSC EYRA, that are not allowed to use the deep-water route therefore have to cross route T at Agersoe Flak in order to enter route-H.

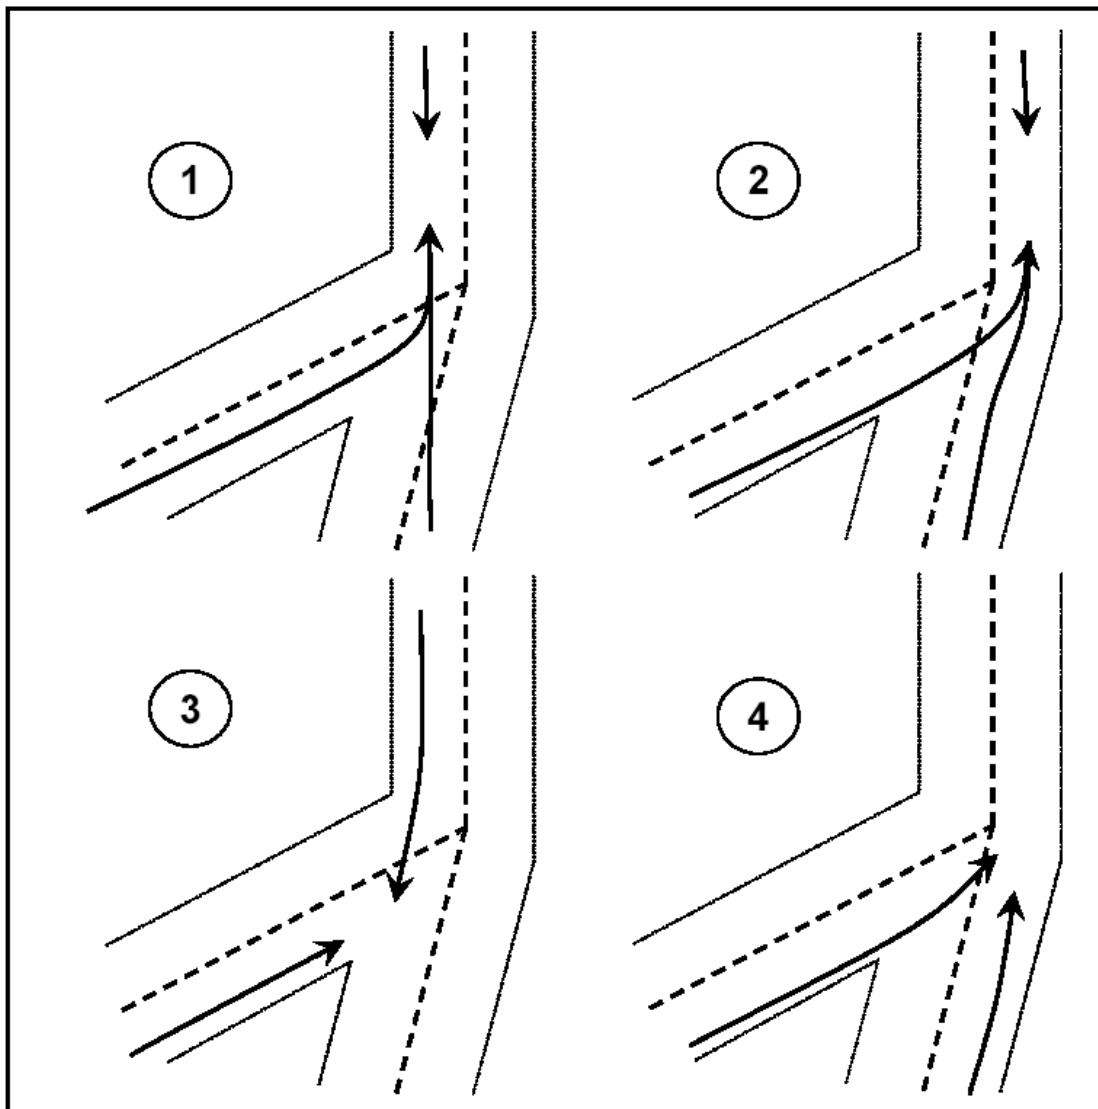
Sketch from Risk Analysis report for the "Agersoe Flak" area (see reference in chapter 3.8)

The Division for Investigation of Maritime Accidents recommends that the Admiral Danish Fleet as the VTS authority takes the initiative, in cooperation with the Danish Maritime Authority, to examine the possibilities to perform navigational assistance services to ships navigating within the VTS area in order for ships to, in due time, avoid meeting other ships in junction points within the VTS area.
